Volume 5, Issue 9, Sept 2010

Thinking Like a Home Inspector:

Identifying Conditions for Structural Concerns: Part Four of a Four Part Series

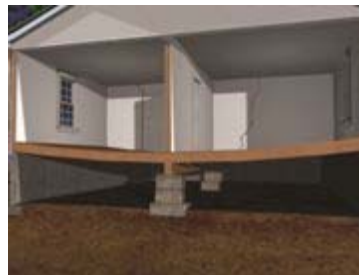
Sloping Floors caused by sagging girders and floor joists.

A common cause of sloping floors is simply settlement of these interior block or steel columns. Weak or unstable foundation soils compress under the imposed column loads. Settlement can also occur over long periods of time or quickly after a specific event that causes changes in moisture content and/or density of the foundation soils. The columns may settle away from the girders and floor joists or the girders and joists may remain in contact with the column as they deform or deflect to follow the

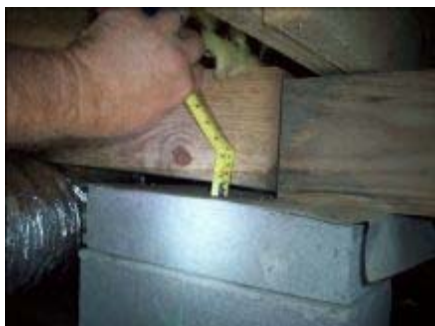
Sloping Floors caused by sagging girders and floor joists.

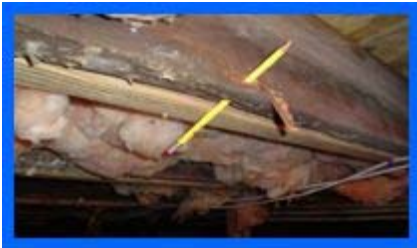
Another cause of sagging girders and floor joists is the improper spacing of those vertical supports. If these support points are too far apart for a given loading condition, the girders may sag between the columns or the joists may sag between the exterior wall and the girder. As the girder and floor joists sag, so do the floors above.

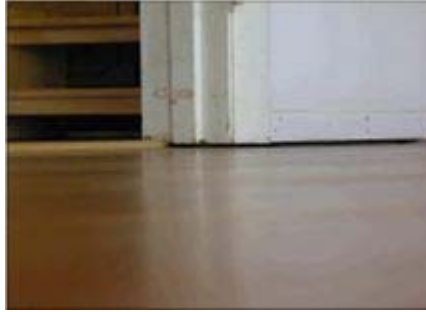
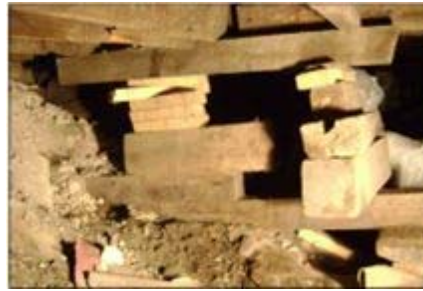
Other signs and symptoms of sagging girders and floor joists can be readily identified with a visual inspection of the crawl space. Separation between the tops of the interior columns and the girders typically indicate column settlement. The homeowner may have also previously identified the problem and come up with their own solution, such

as adding shims between the column and girder or constructing additional vertical supports to address sagging between existing columns.
